Sun Fire™ X4100 and Sun Fire X4200 Servers Product Notes

Part No. 819-1162-24
November 2006, Revision A

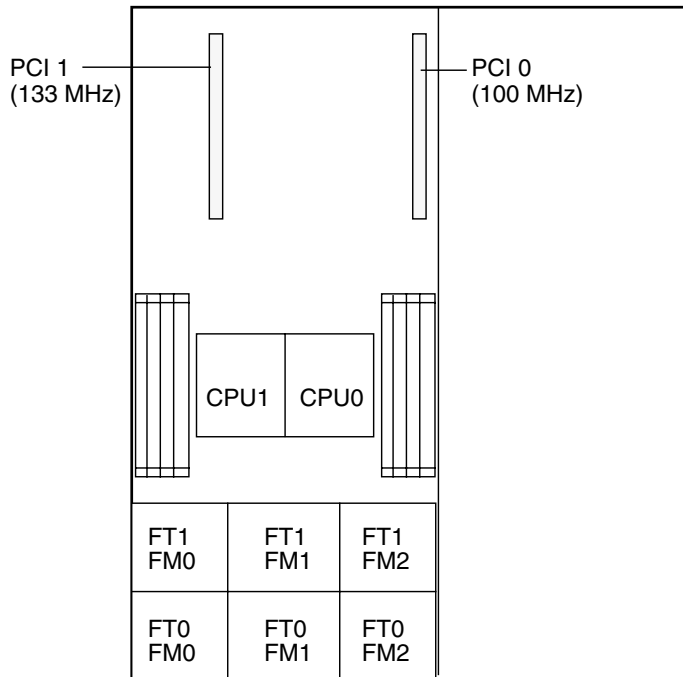
FIGURE 1 Sun Fire X4100 Designation and Speeds of PCI Slots

Front panel of server

See [FIGURE 1](#) or [FIGURE 2](#) for the location of the PCI slots.

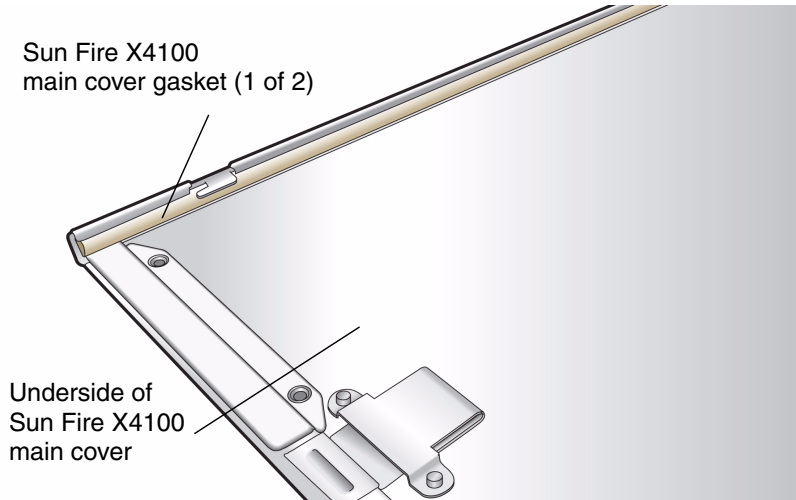
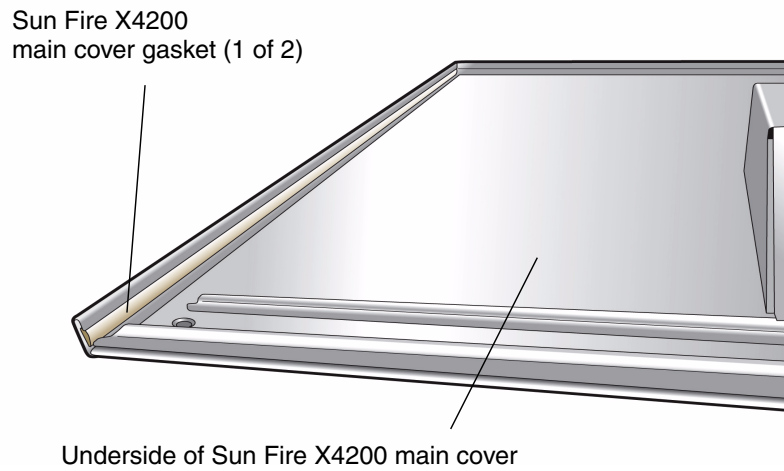
FIGURE 3 Location of Main Cover Gasket

4. **If you installed 4-GB DIMMs to a server that did not previously have 4 GB DIMMs installed, do one of the following:**
 - If you have a Sun Fire X4200 server, skip to [Step c](#).
 - If you have a Sun Fire X4100 server, you must replace existing gaskets. Continue with [Step a](#).
 - a. **Remove the existing gaskets from the underside of the main cover. See [FIGURE 3](#) for the location.**
 - b. **Remove any adhesive left from the old gaskets by cleaning the areas with isopropyl alcohol.**
 - c. **Remove the backing strip from the adhesive on one of the new gaskets.**
 - d. **Set the new gasket in place, being careful to align the end of the gasket with the front edge of the main cover. See [FIGURE 3](#).**
 - e. **Press down on the gasket to remove any trapped air and secure it firmly to the main cover.**

f. Install the remaining gasket on the main cover.
